(12) UK Patent Application (19) GB (11) 2 297 598 (13) A

(54) Improved beer line cleaning system

(57) The system comprises a number of beer kegs 10 and a number of dispensers 17, 18 connected through lines 12, 15 which must be cleaned with water 32 and/or cleaning fluid 30, each dispenser having a closely associated sensor 16 which detects the presence of water in the line and disables the dispenser, so as to maximise the amount of beer that may be dispensed for sale.

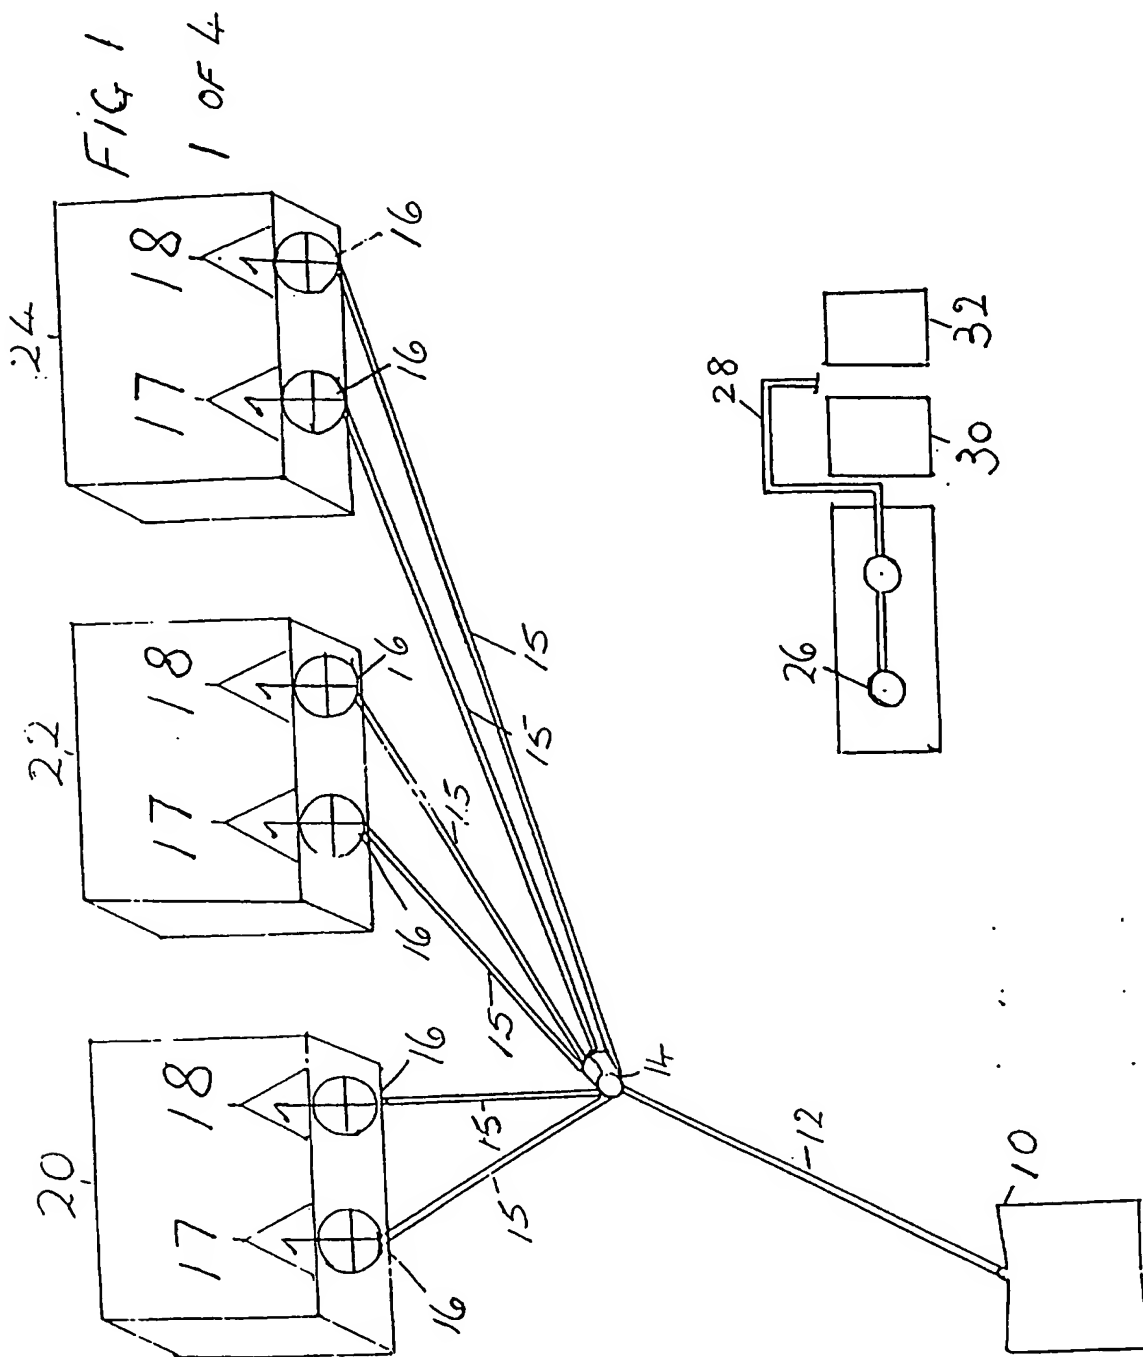
A keg of beer supplying three separate bars.

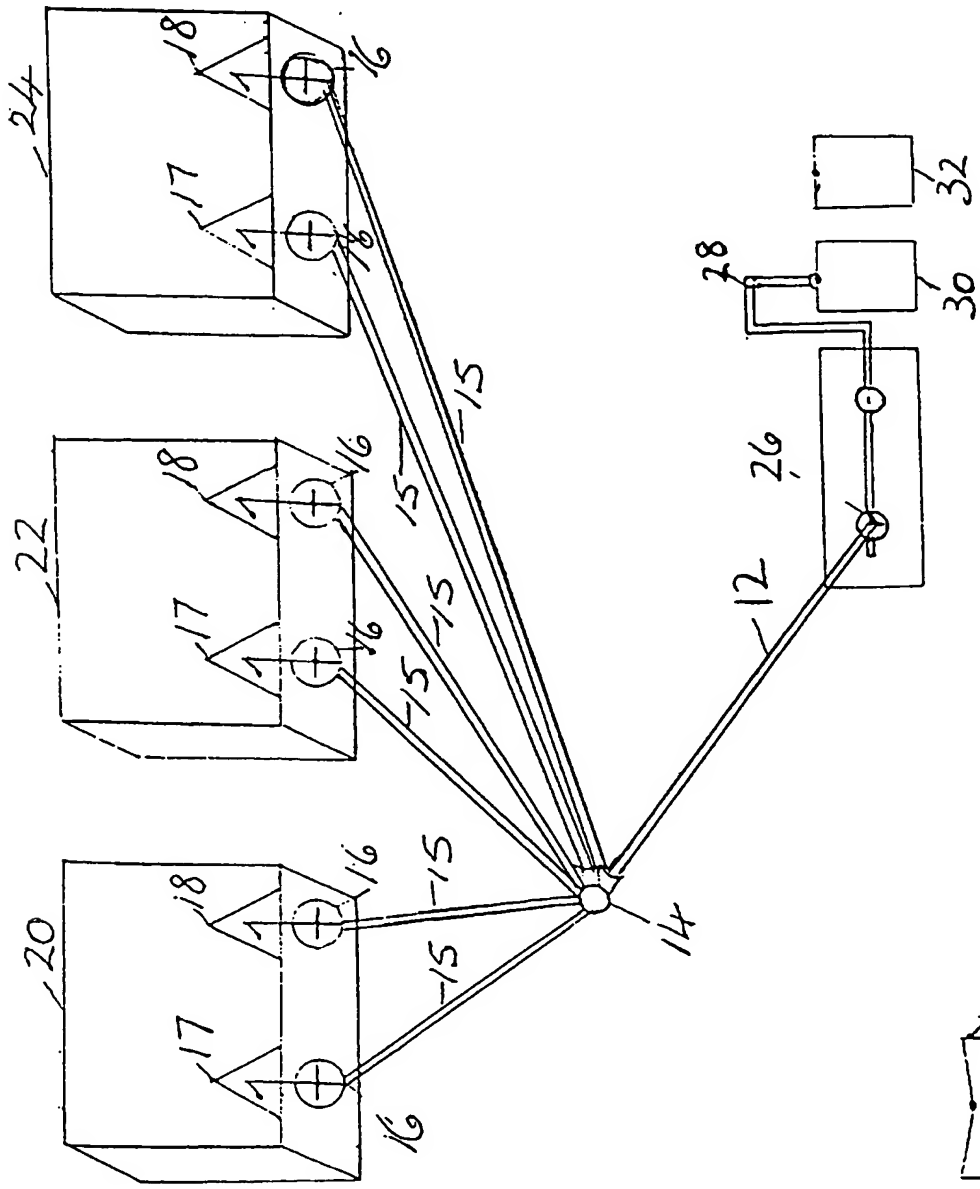
FIG 1
2 OF 4

The keg of beer supply connection is affixed to the ring main cleaning system which is coupled to the cleaning fluid bottle, the fluid forcing the beer from the pipes.

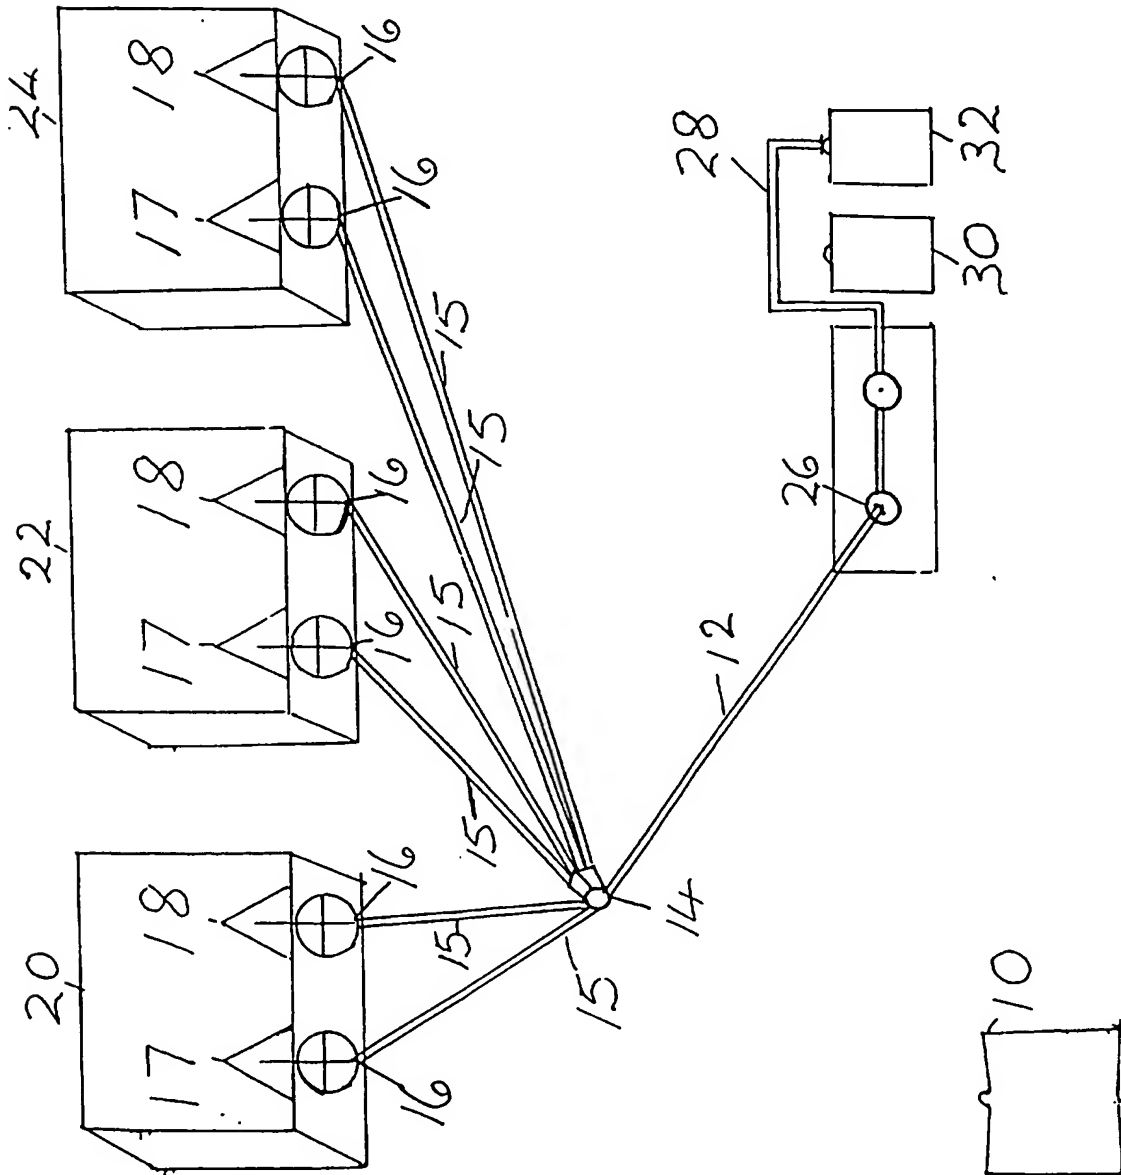
FIG 1
3 OF 4

The water cleaning bottle is coupled to the ring main system and the pipes are flushed out.

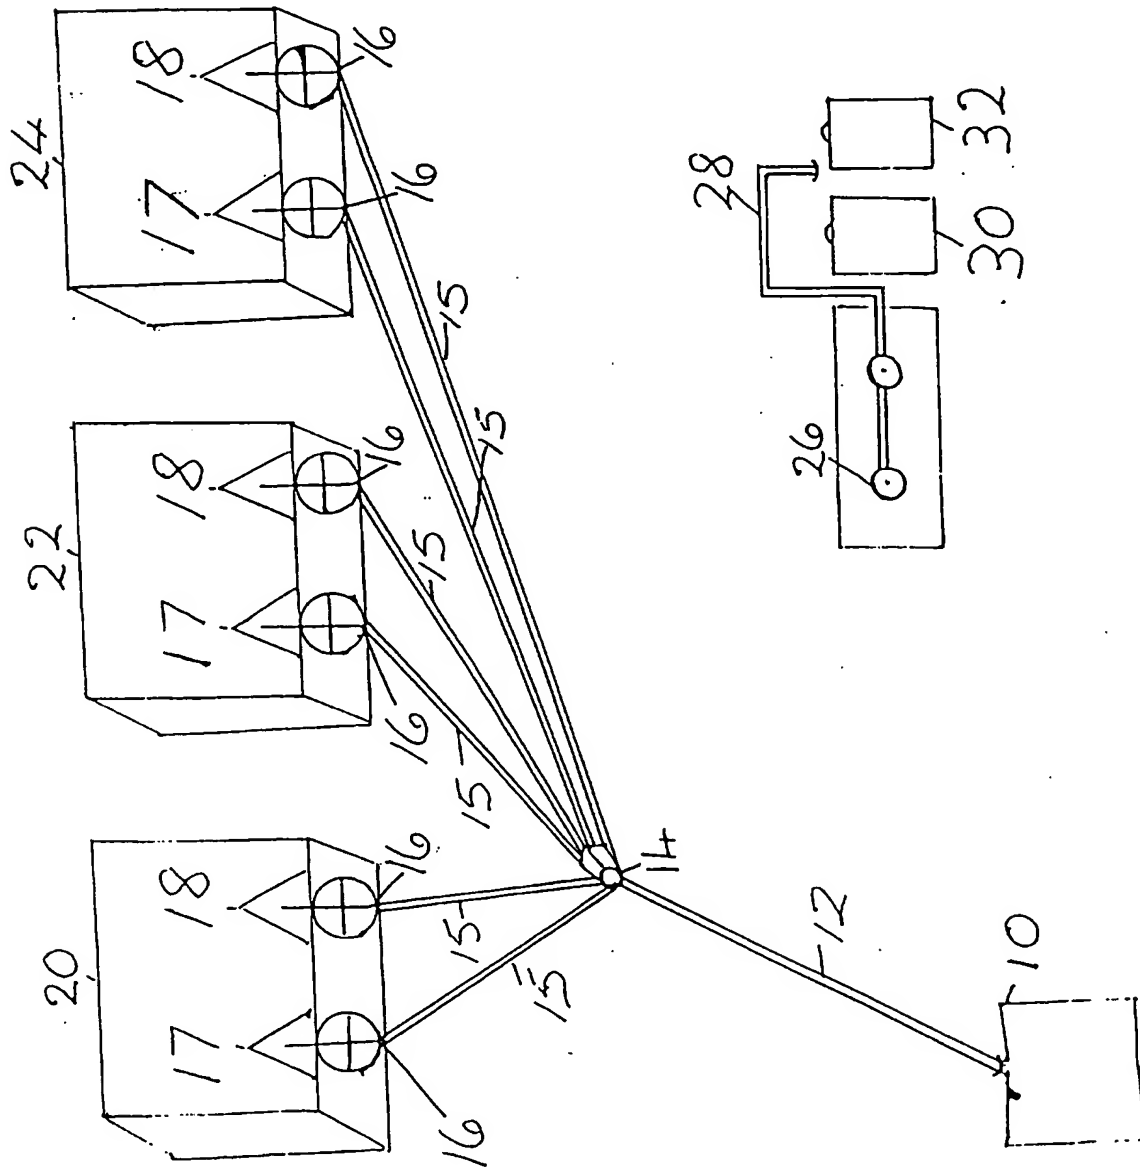
FIG 1
4 of 4

The beer pipe is now returned to the keg of beer and the beer is introduced back into the pipes.

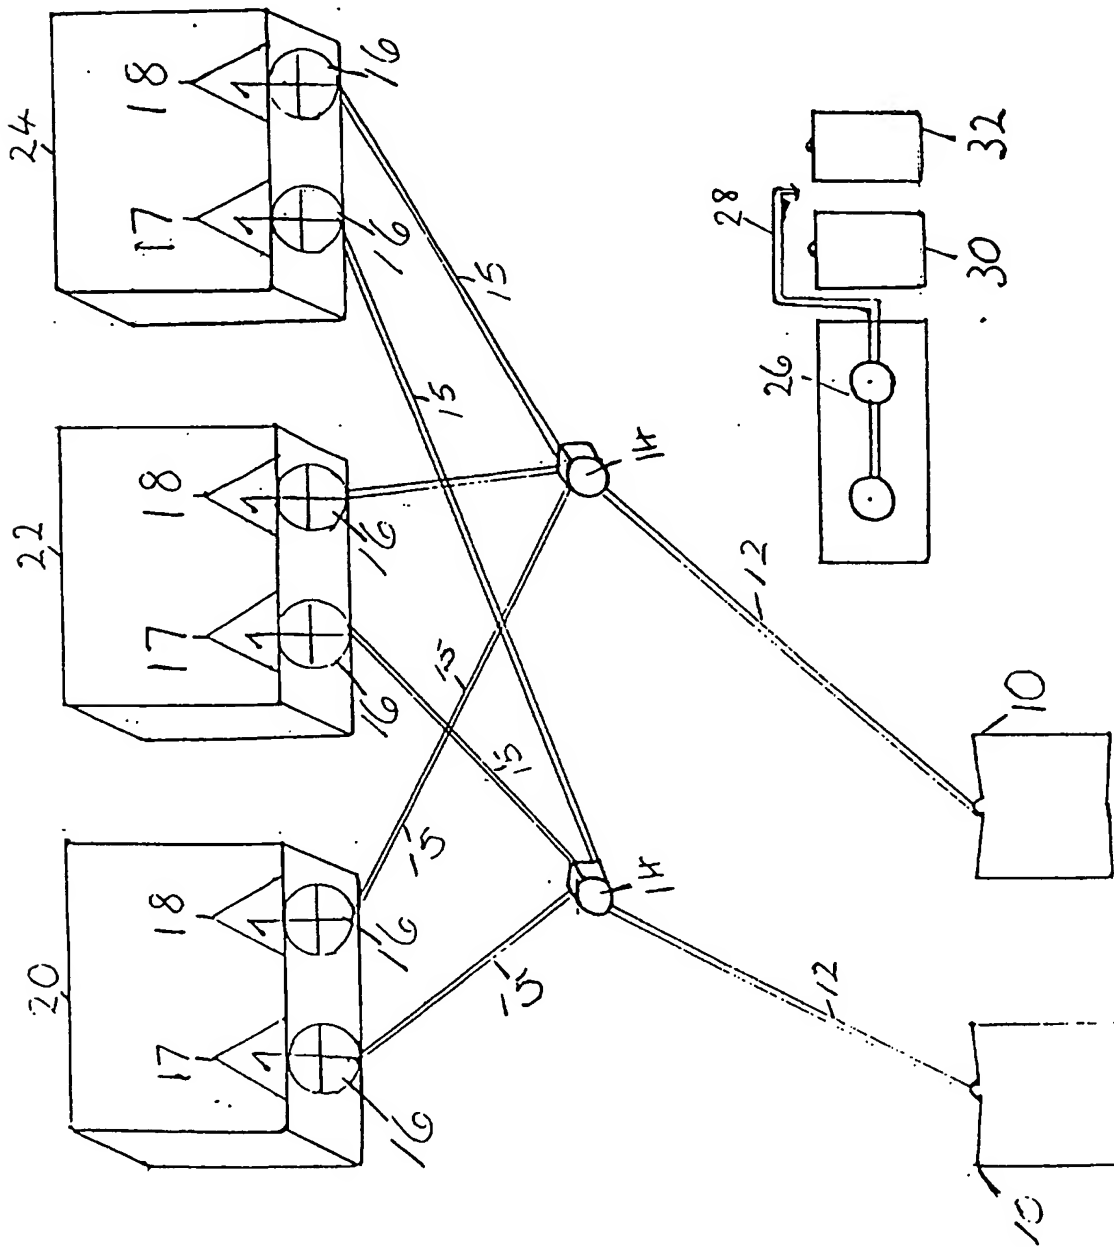
FIG 2
1 OF 5

We now have two kegs feeding beer through individual motors and fonts on all products.

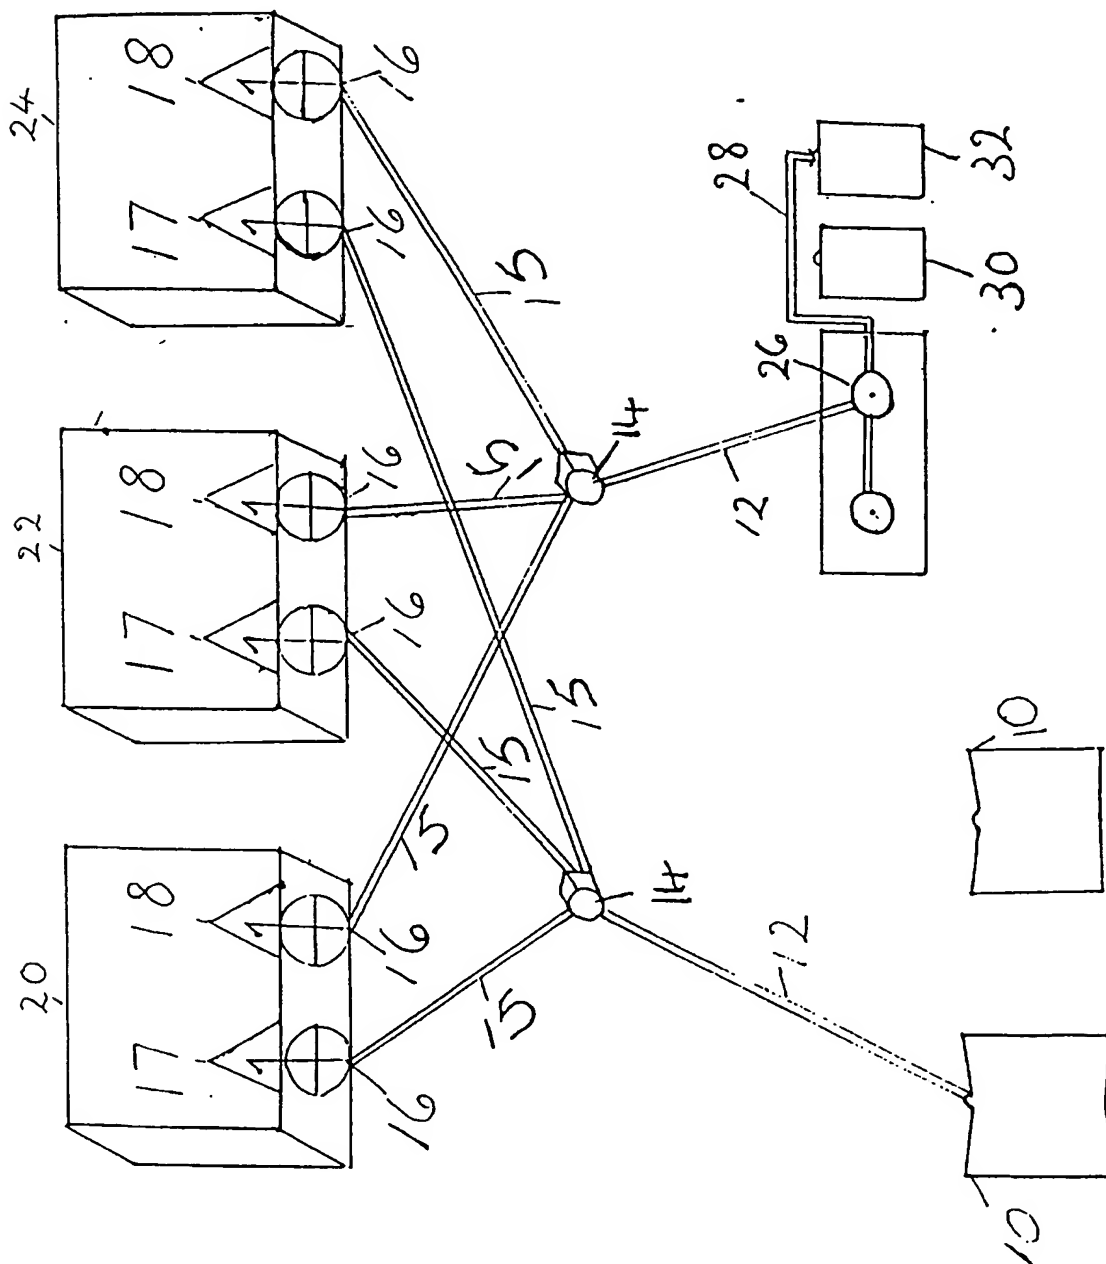
FIG 2
2 OF 5

One keg is supplying beer while the other keg connection is attached to the ring main system, which is coupled to the water bottle, the beer which is in the pipe is sold, the water sensor will immobilise the front when water appears.

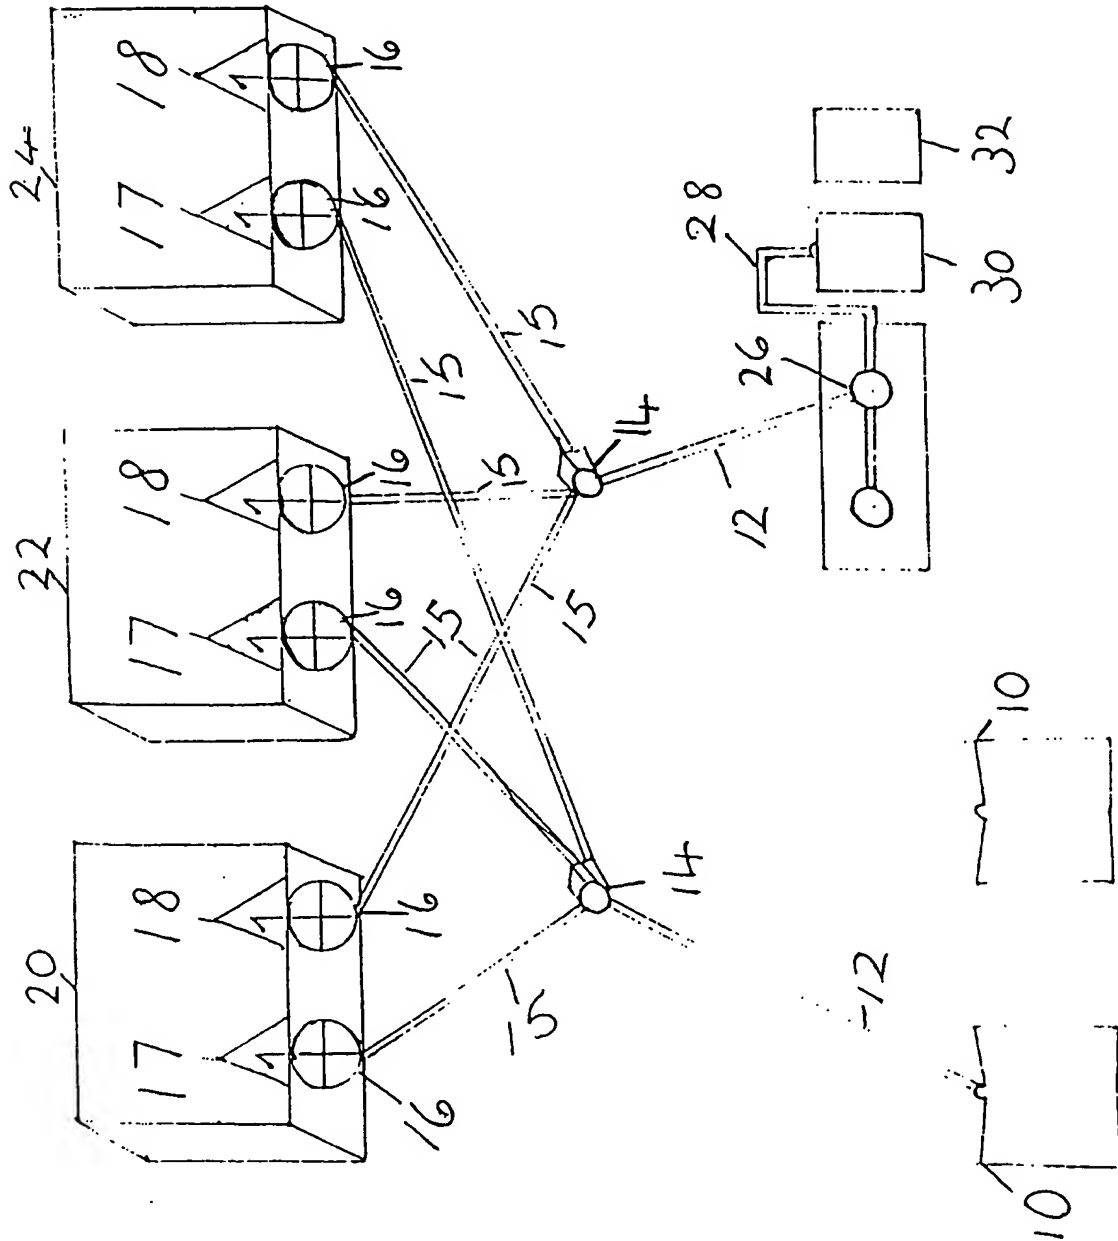
FIG 2
3 OF 5

The cleaning fluid bottle which is now coupled to the ring fluid is introduced into the pipes and left for recommended periods.

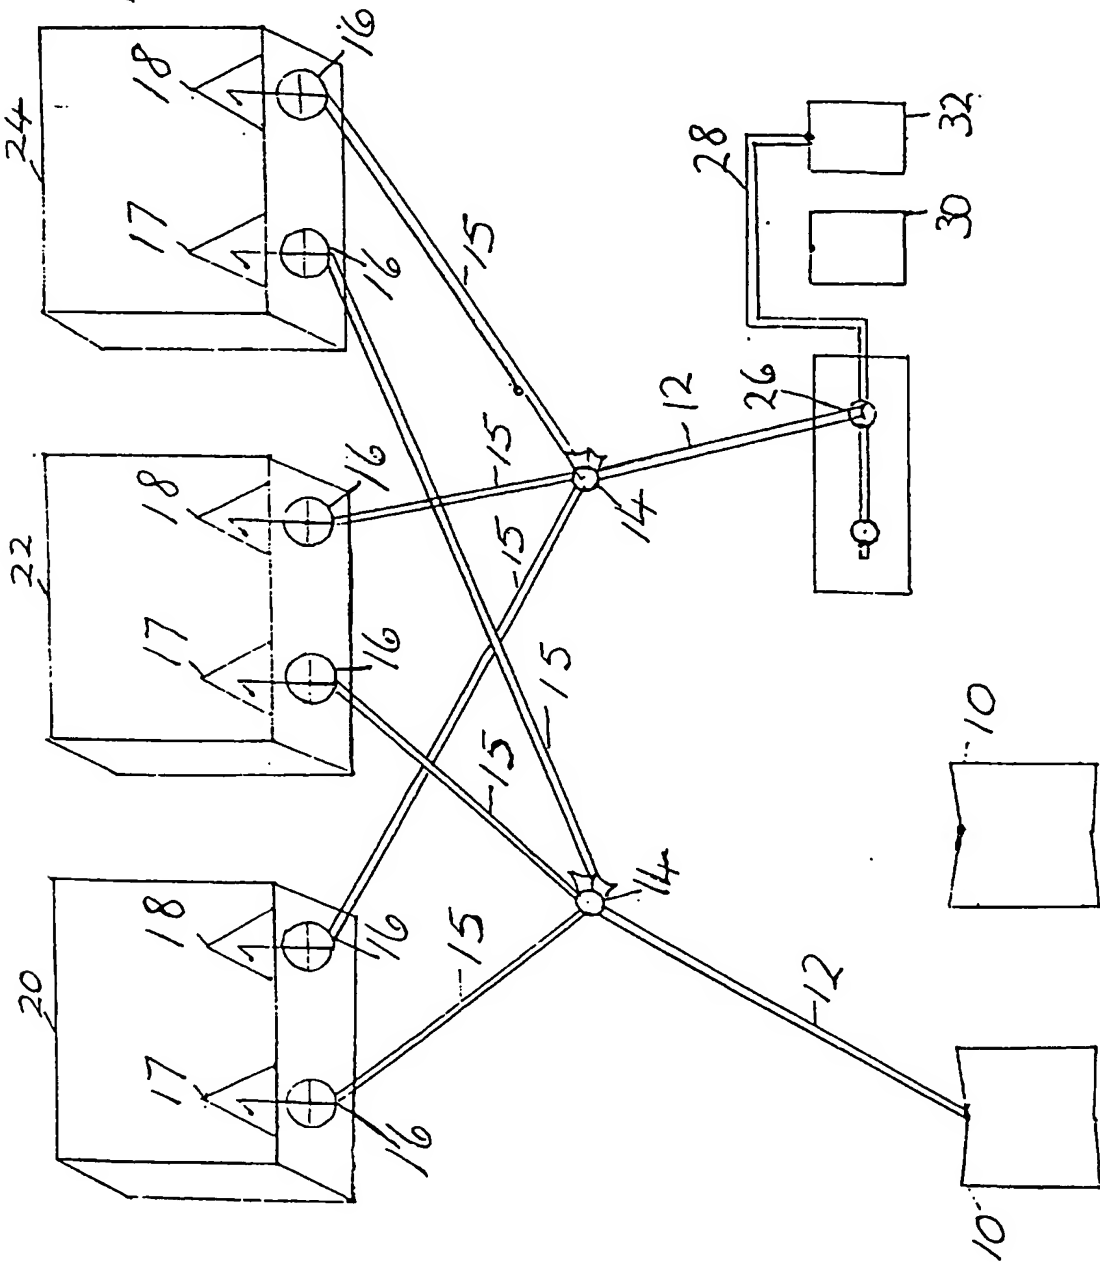
FIG 2
4 OF 5

The water supply is again affixed to the ring main, the pipes are then flushed to taste.

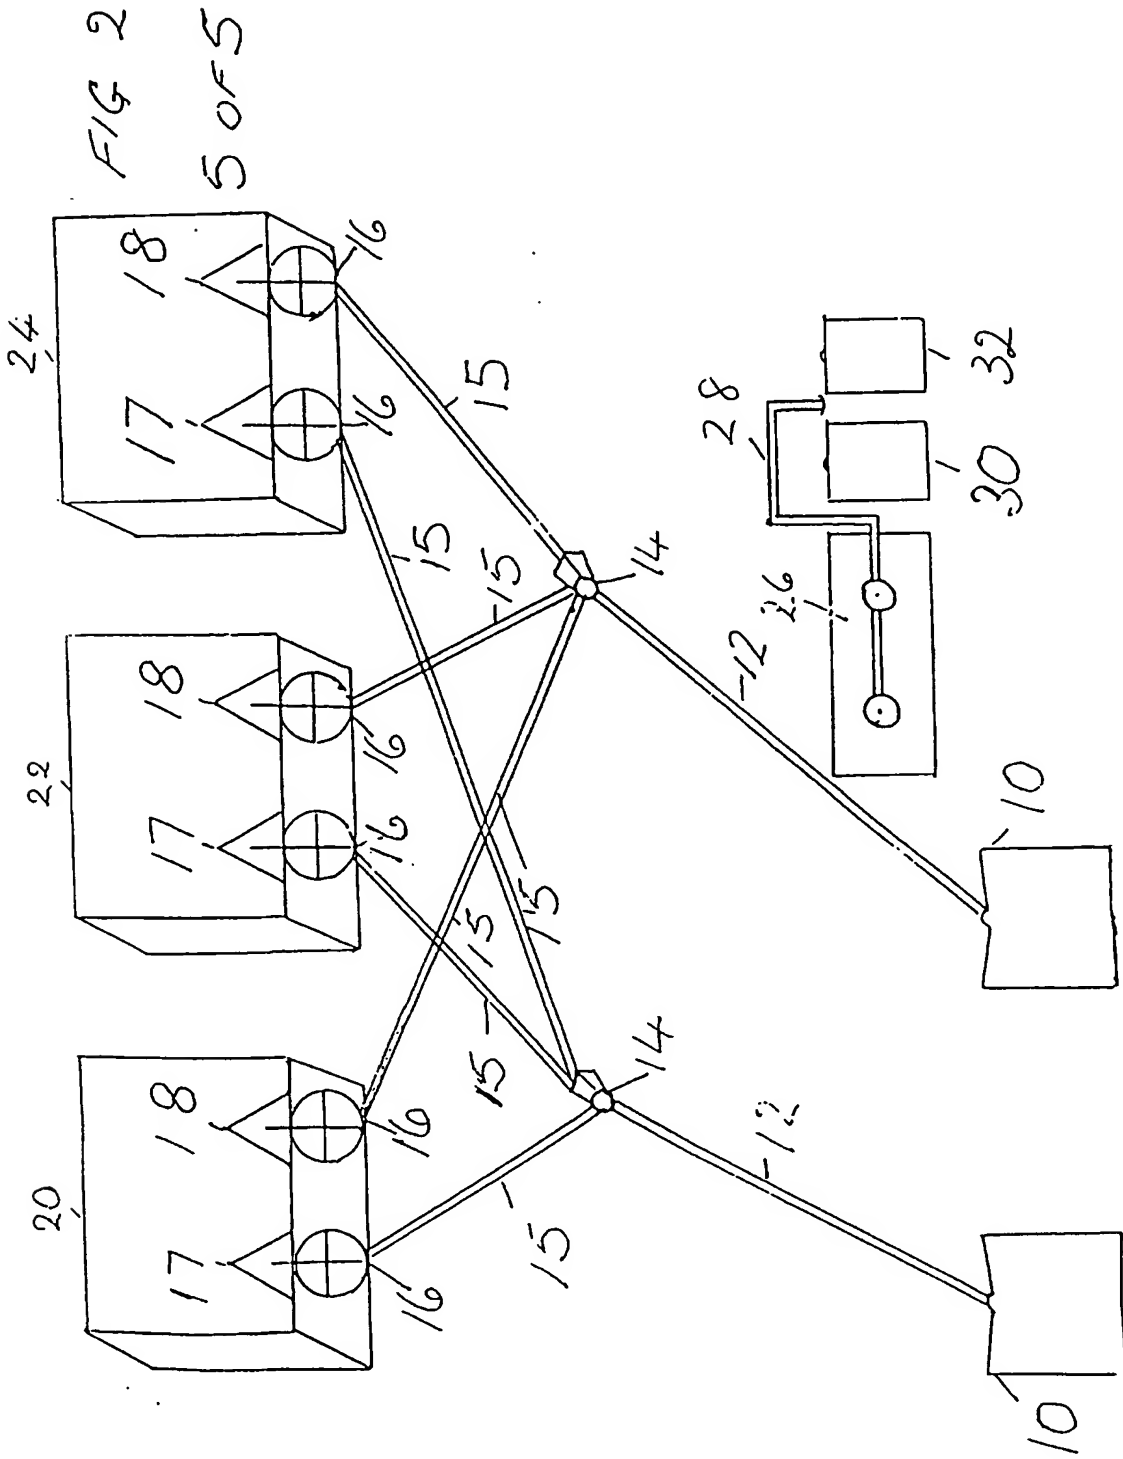
9/15

The keg connection is now replaced and the beer is returned to the pipes ready for serving.

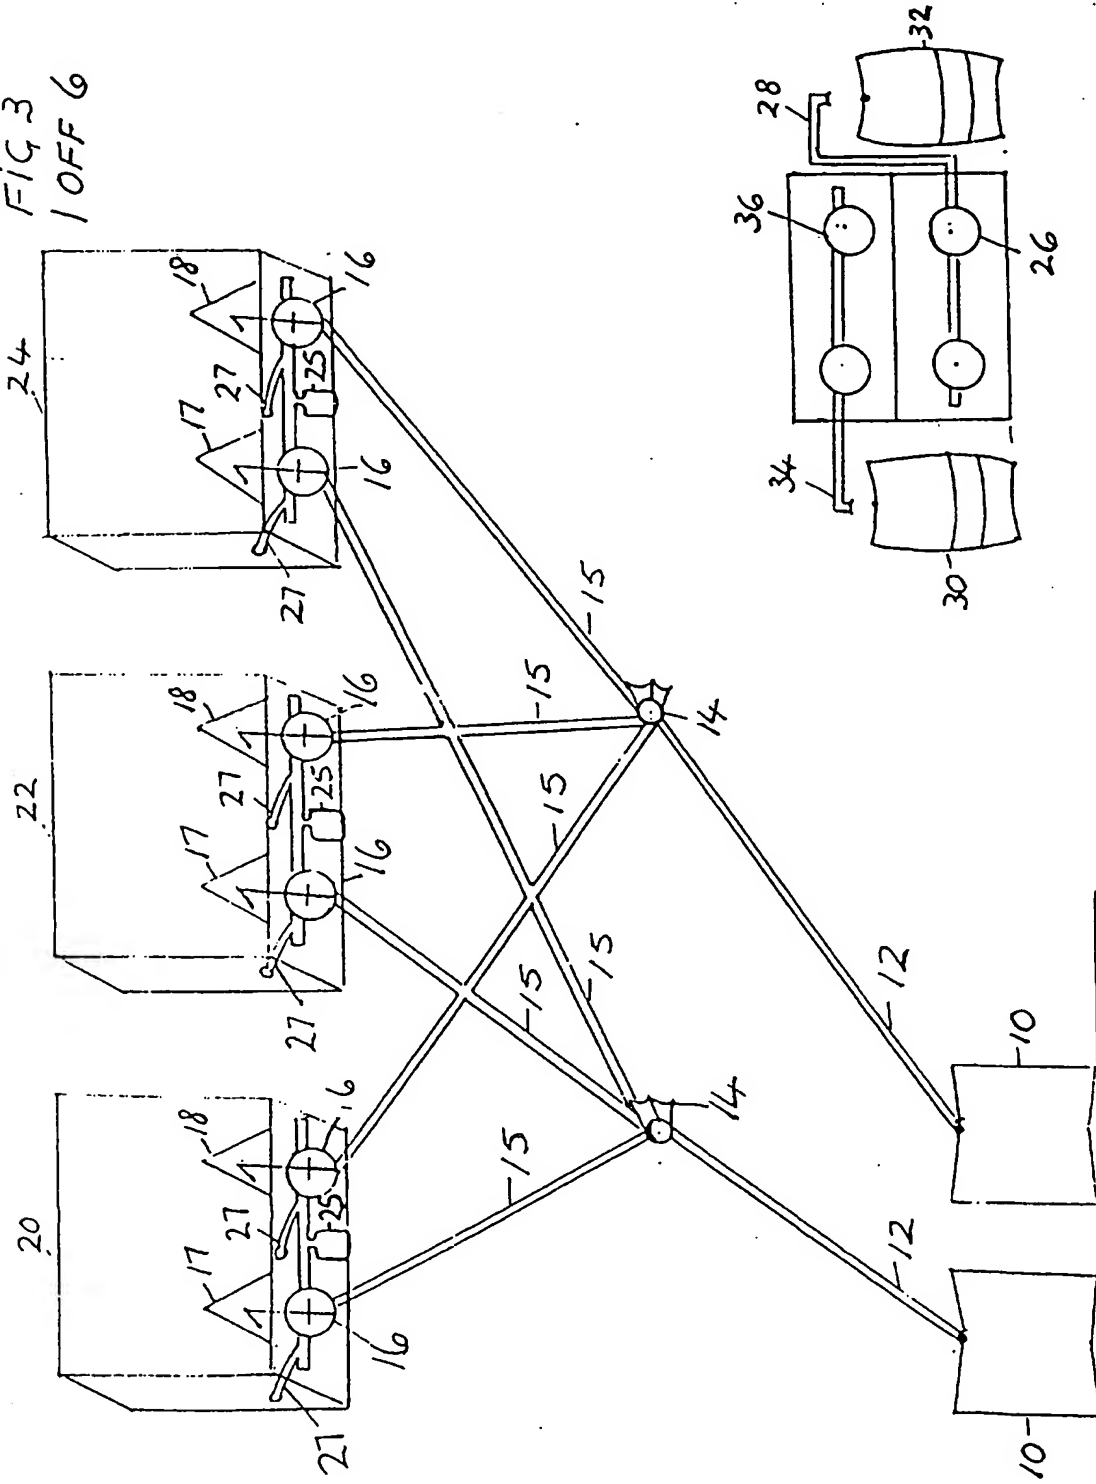
FIG 3
1 OFF 6

We now have two kegs feeding beer through individual motors and fonts on all products.

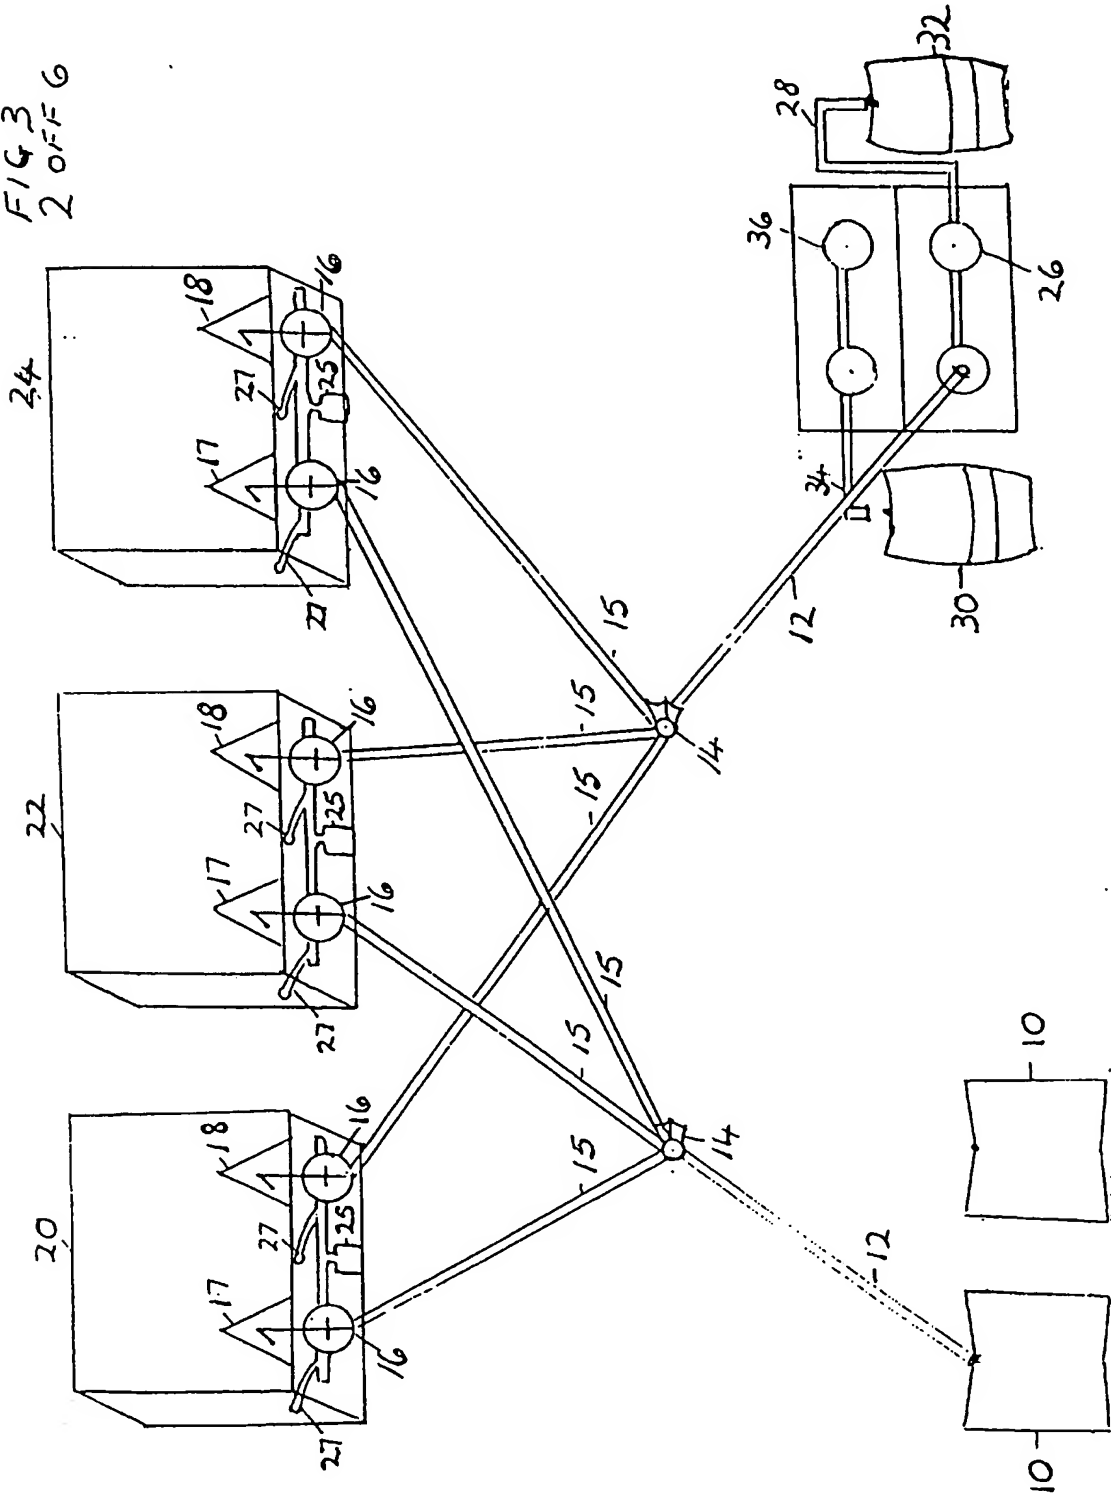
FIG. 3
2 OFF 6

One keg on each product is supplying beer while the other keg to motor pipe is attached to the water ring main system. The beer which is being pushed from the pipes by the water is sold to customers. The *sensor* will immobilise the font when water appears.

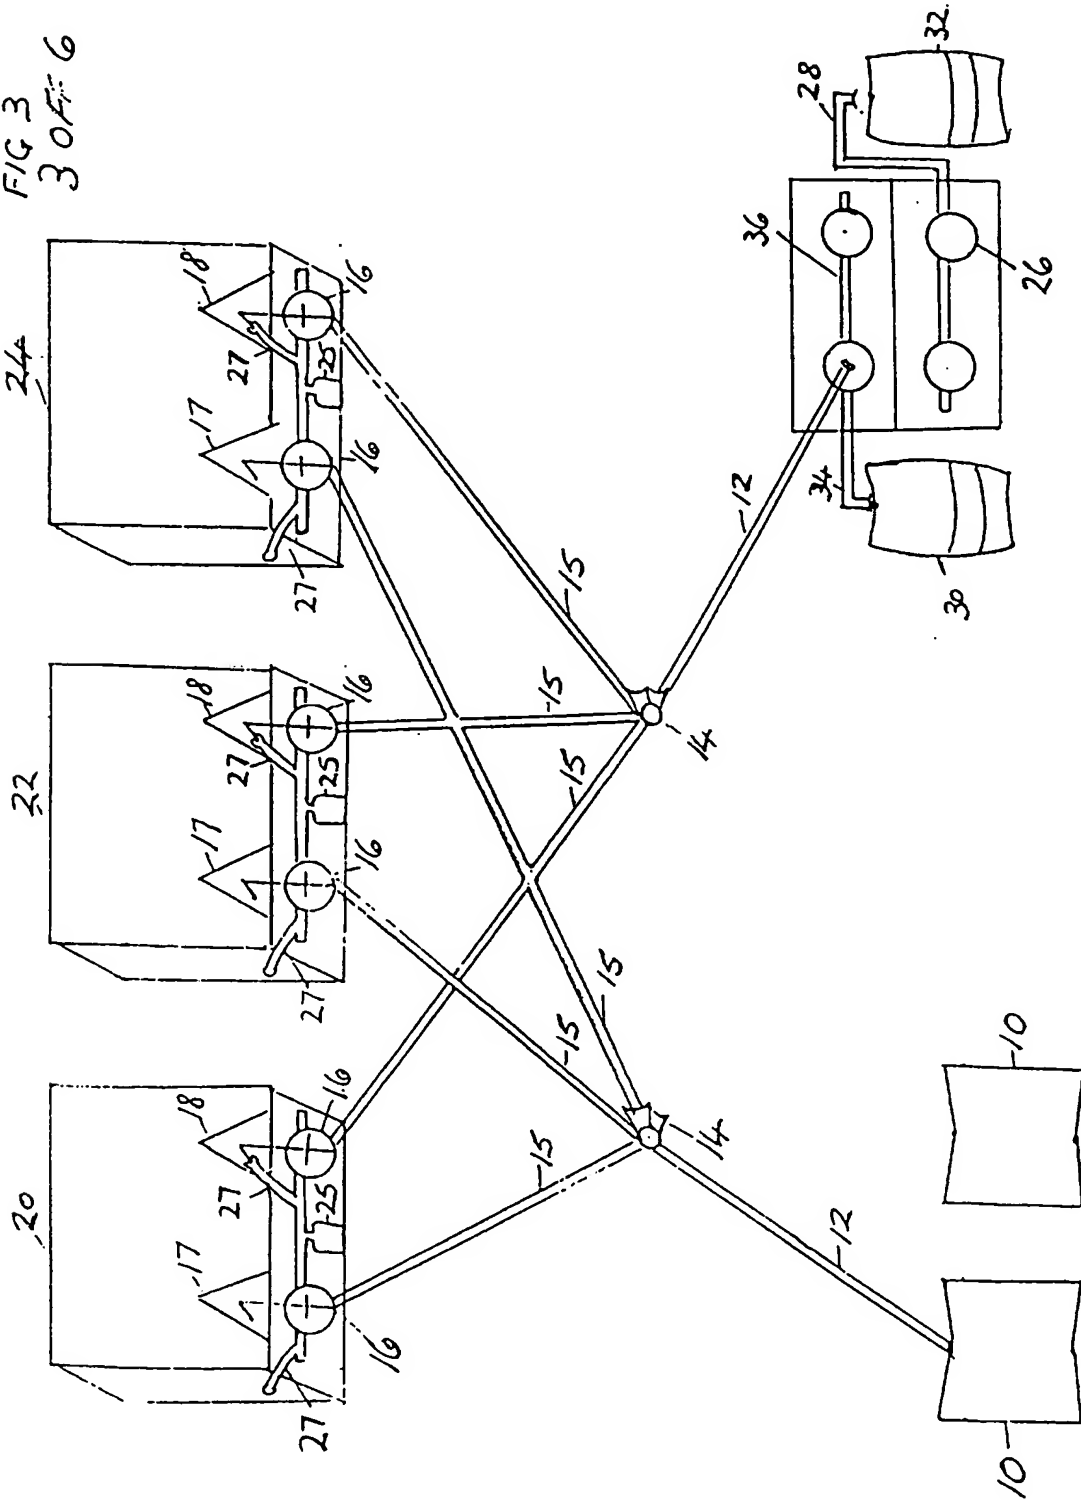
FIG 3
304-6

As each font is immobilised, the flexy pipe must be attached to the font dispenser, so as to enable line cleaning waste to filter through into the waste disposal drain. The keg to motor pipe is attached to the ring main cleaning fluid system. The cleaning fluid is introduced into the system. The *sensor* will immobilise the font when cleaning fluid appears. The fluid is left in the system for a recommended period.

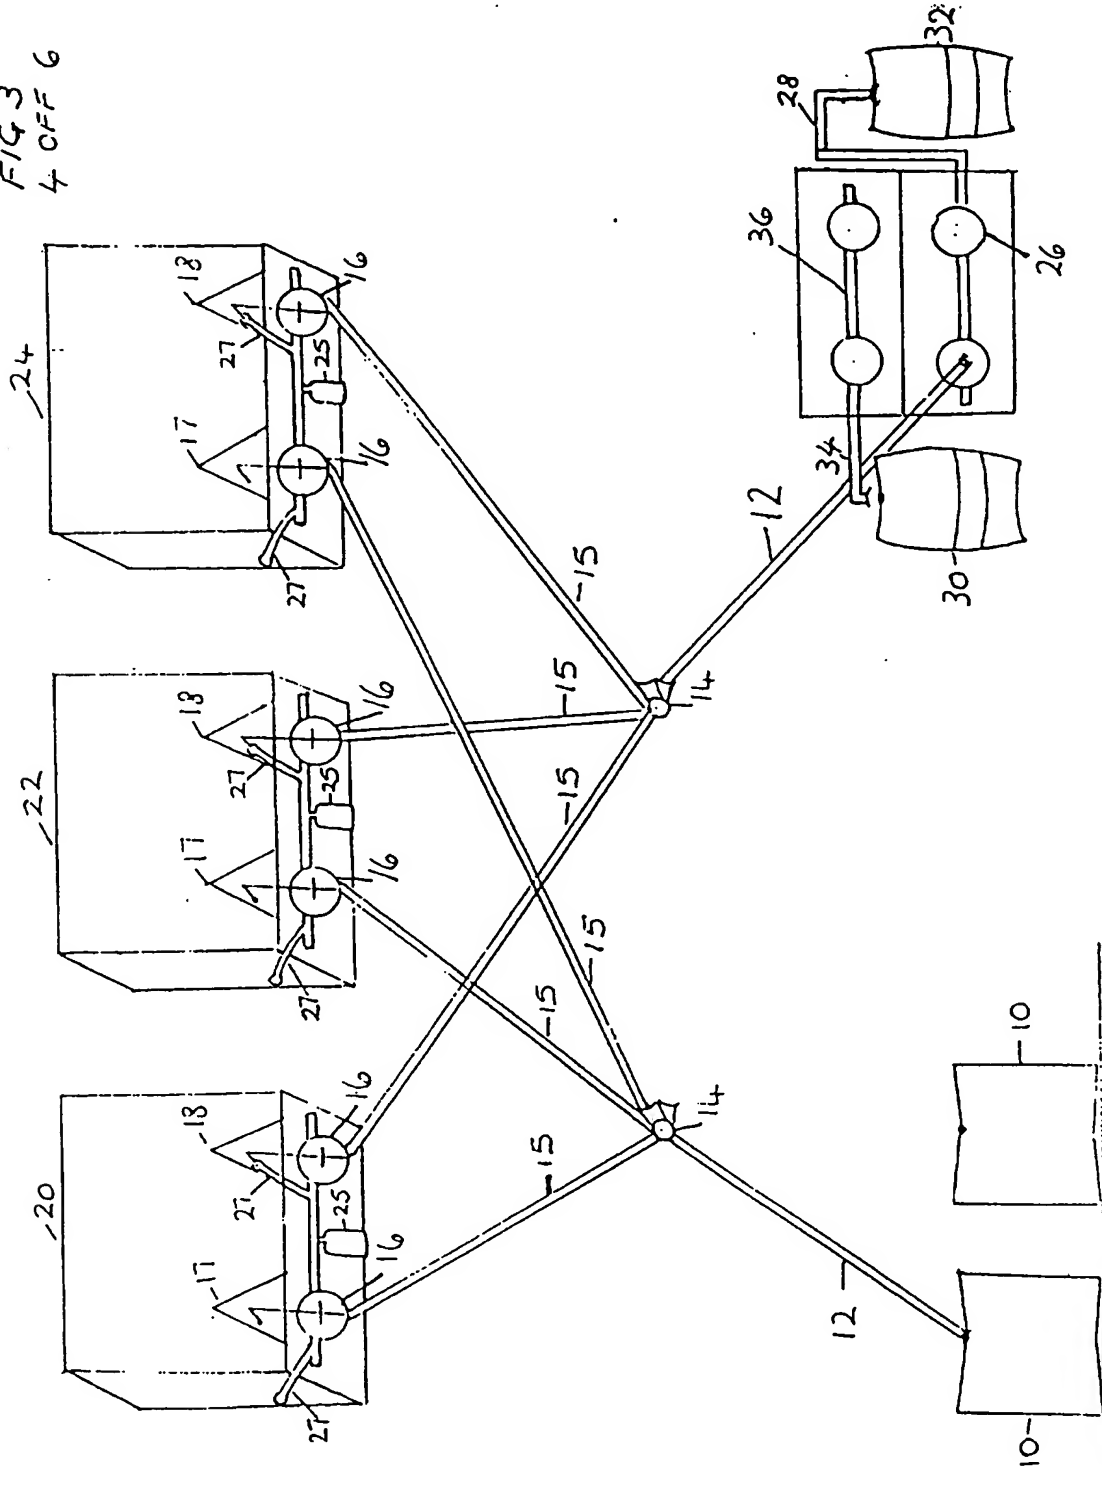
FIG 3
4 OFF 6

The keg to motor pipe is again returned to the water ring main system - the beer pipes are flushed with water.

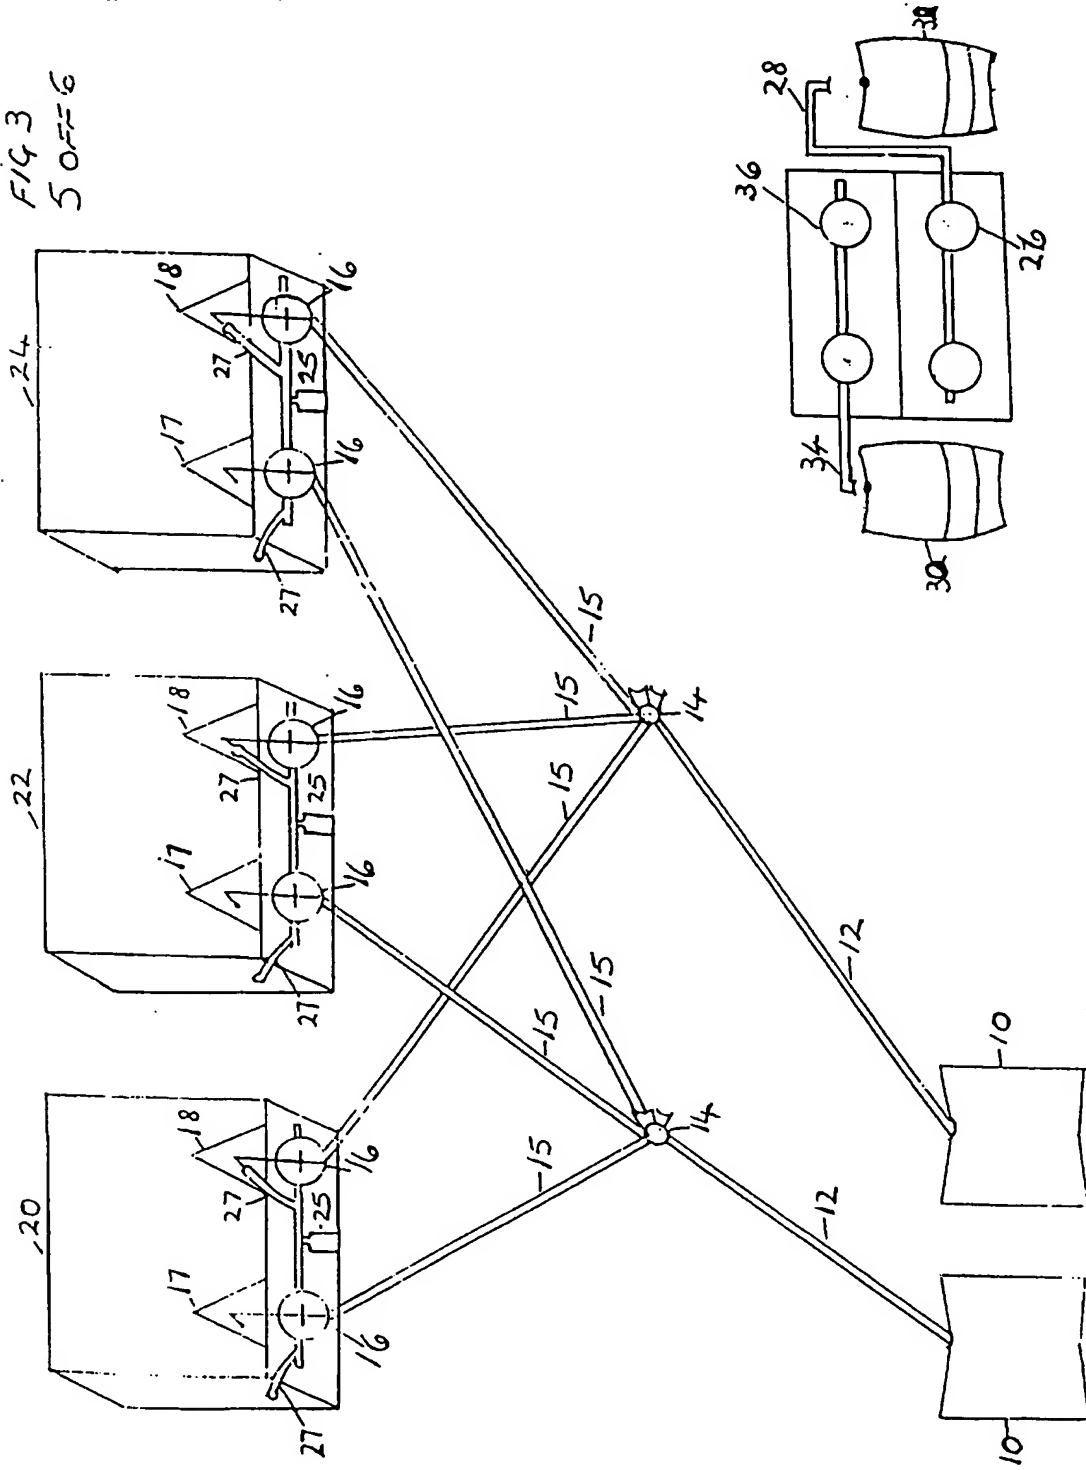
FIG 3
50556

The keg to motor pipe is now returned to the keg of beer. The beer is returned to the beer pipes pushing the water out. The *sensor* will immobilise the font when the beer appears.

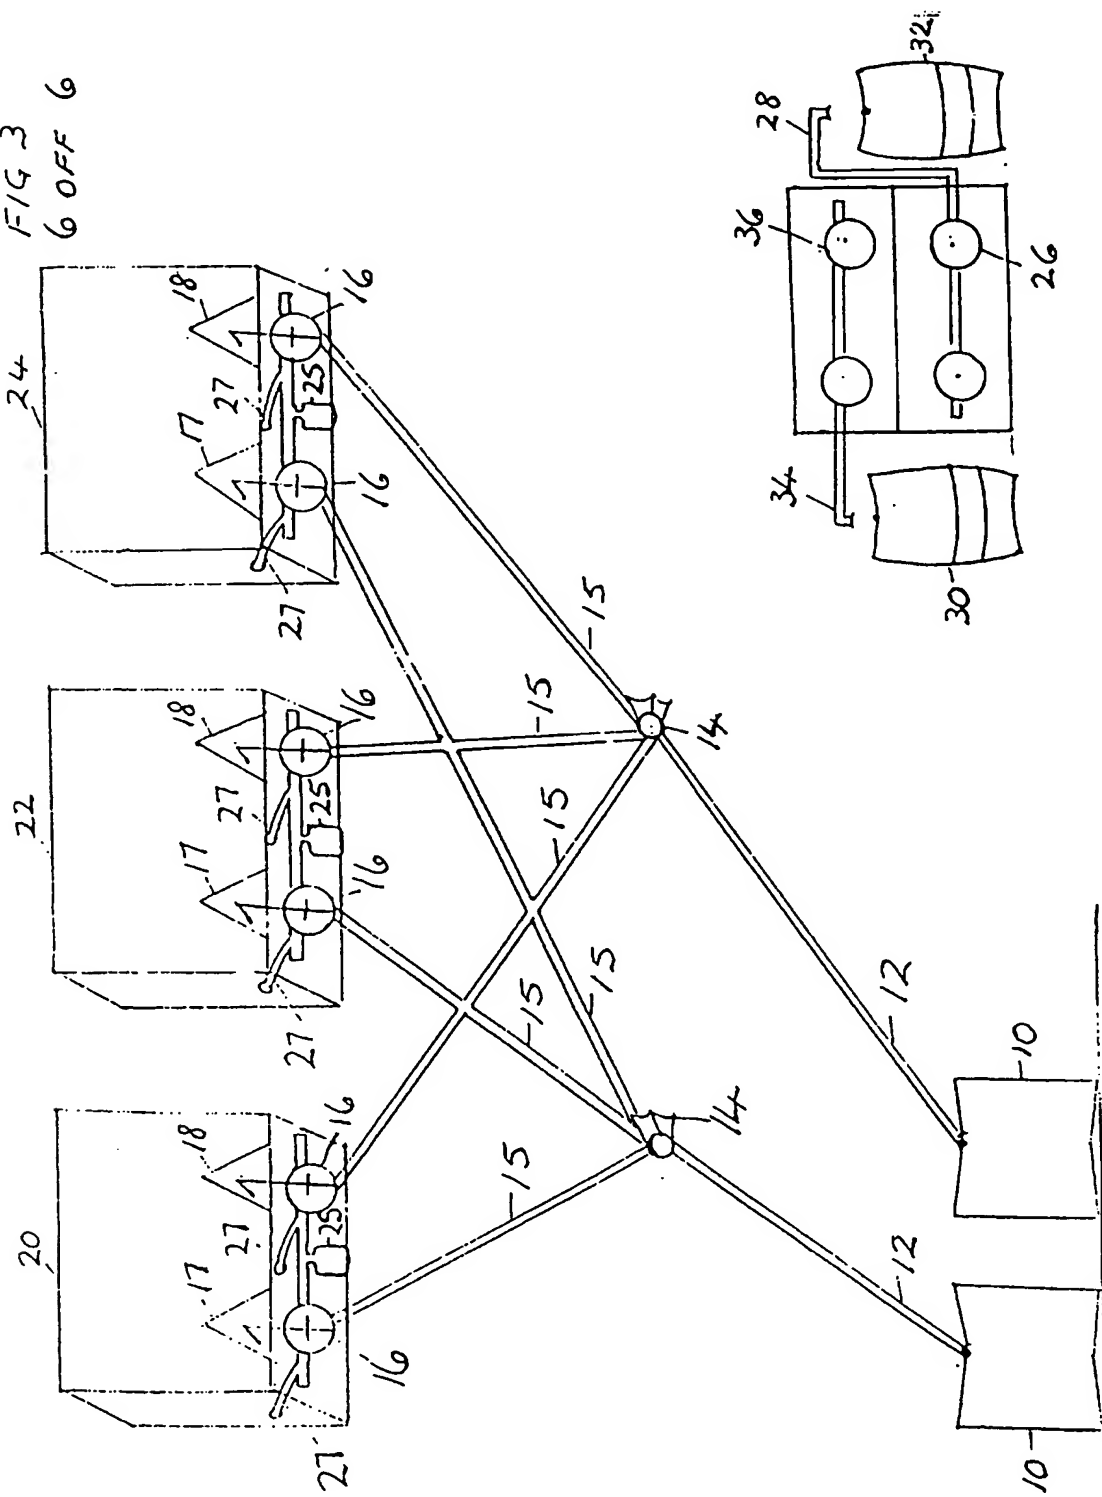
FIG 3
6 OFF 6

The flexy pipe is now removed from the dispenser. The cleaning operation is now completed.
